## Wet Damage on Bulk Carriers

## How to avoid wet damage on bulk carriers

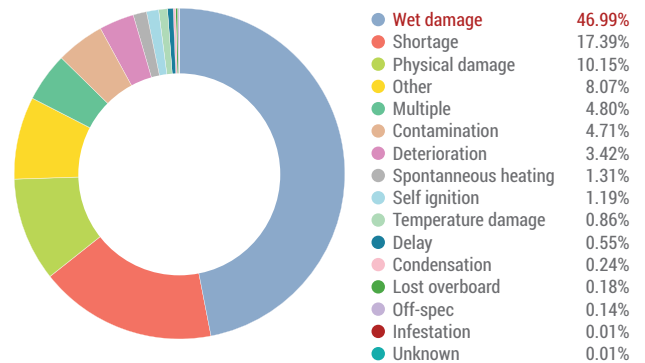
## P&I: Most common types of cargo claims on bulk carriers

It can be seen from the charts that wet damage is the second most common claim type and the most costly. These figures are based on more than 600 cargo claims on bulk carriers.

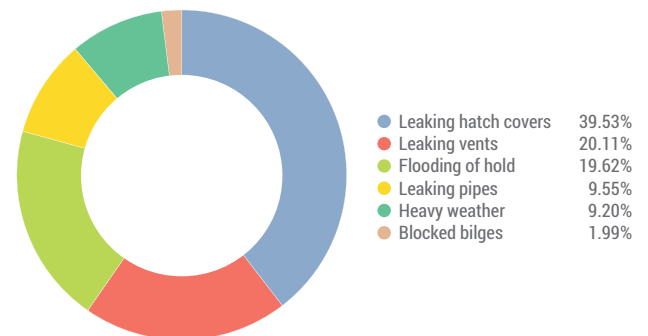
## P&I: Most common causes of wet damage on bulk carriers

For wet damage claims, heavy weather and leaking hatch covers are both the most common and the most costly type. Indeed heavy weather and leaking hatch covers are coinciding incidents as the cargo hatch covers may be washed over by green sea on deck when the vessel sails through heavy weather.

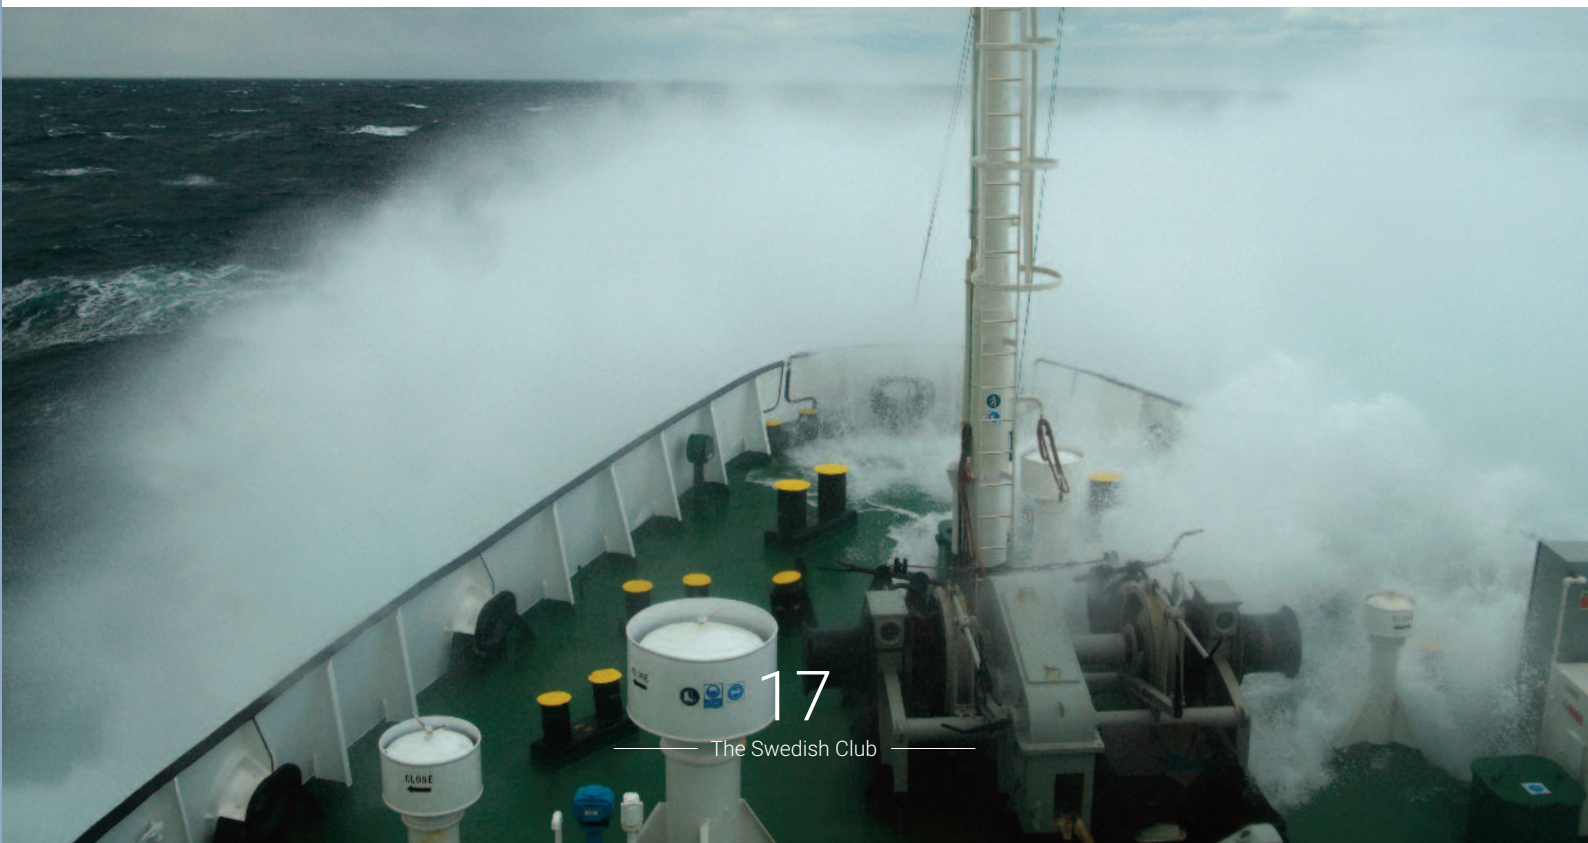
A suitable sealing force is required for the sealing arrangement to function correctly. This is not achieved by the sealing alone, but is a result of the design of the hatch cover/coaming system. It is of paramount importance for the tightness of the covers that the compression bar position in relation to the seal/gasket is correct, and that the support pads, stoppers and locators are arranged in an optimal way. Changes in one part of the arrangement can lead to changes in its other components.

Sealing between the hatch covers and coaming is generally achieved by rubber packing fitted to the panels and tightened against the edge of a compression bar fitted on the hatch coaming. The gasket is made of a solid rubber material with a cross-section of various cavities for producing the desired sealing force for a wide range of deflections.

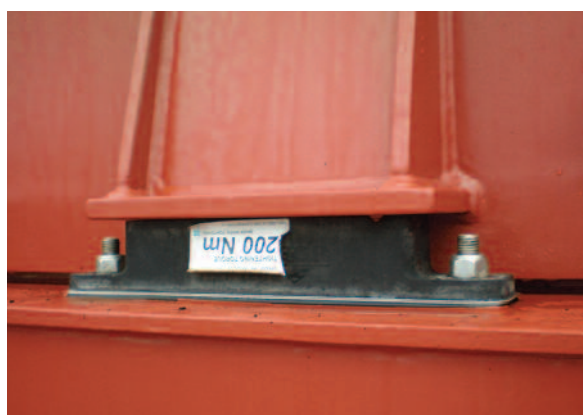
When repairing the bearing pads it is important to check/replace the gaskets at the same time. If the gasket has lost its original elasticity there will not be enough compression of the gasket to achieve a proper weathertightness of the hatch covers.

After the repair of the bearing pads the weathertightness of the hatch covers should be tested with a hose test or using ultrasonic testing equipment.

Bearing pads need to be repaired when the pad is worn approximately 5 mm, i.e. well before there is steel to steel contact between the coaming and the side plate of the hatch cover panel. Proper function of the hatch cover gaskets and the weathertightness of the hatch covers is risked when the height position of the hatch covers is shifted from the original.

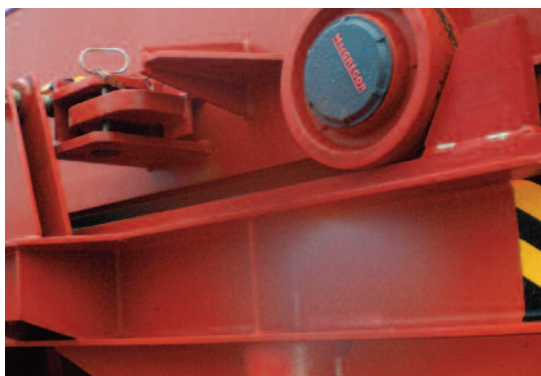
Locators and stoppers:

- Ensure correct positioning of panel both transversal and longitudinal
- Allow coaming deflection
- Control rubber compression in the cross-joints
- Absorb acceleration forces

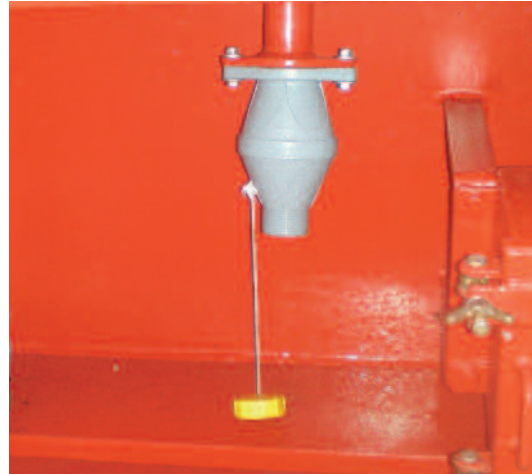
Drain valves are located close to hatch corners and the joints between the hatch cover panels. In rough sea the ship hull flexes, generating movement between the hatch cover panels and the coaming. This might cause leakage in the hatch cover sealing system. Leak water passing the seals is captured by the drain channels and the water is led to drain pipes on the coaming.

Non-return drain valves are installed to the drain pipes. They allow water to drain out onto the deck but stop water from the deck entering the cargo hold.
