TTS - Jib rest collision prevention

It's a fact that many ship board cranes regularly experience heavy damage of the steel structure and deformations of the jib bearing due to shock impacts. This often occurs when the limit switches that are required to keep the crane within the allowed working range are not correctly adjusted. As you can see from the images here, around 80% of the repair enquiries we receive are based on a collision with the jib's own rest located on the crane column.

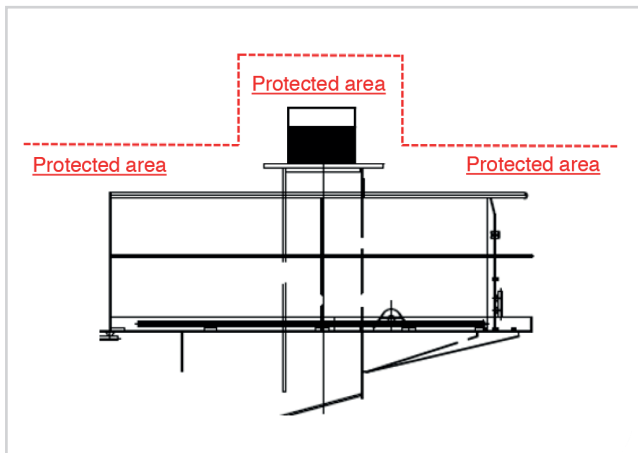
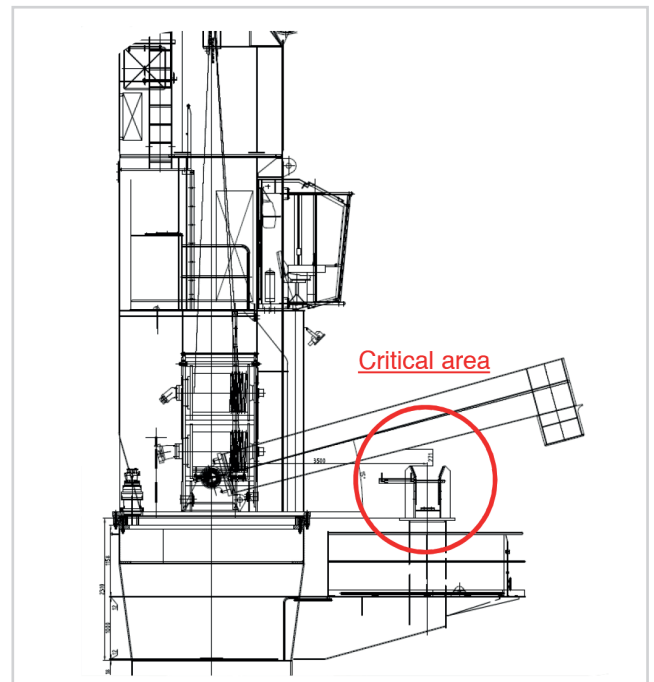
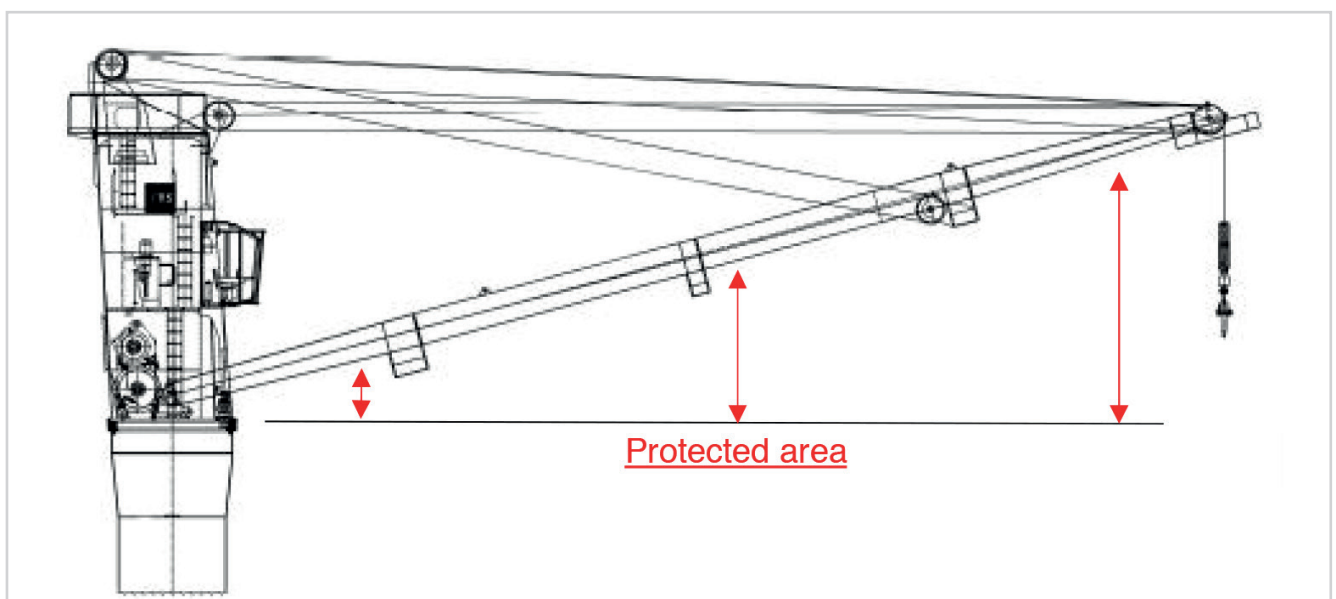
So, how does the system work? As you can see from the illustrations here, we simply combine a slewing range limitation along with a luffing range limiter for the critical area. This effectively is a small amount of hardware that is a very cost-effective solution because it provides an economical alternative to expensive repairs. The system can be tailored to meet all type of cranes and ship board applications.

In order to avoid these type of scenarios, TTS has developed a jib rest collision protection device that blocks the area around the jib rest, even when the limit switches are not correctly aligned.
